# **K&T #14**

## **Inspection Overview, Observed Defects & Corrective Actions**

Jason Sobczynski  
Next Generation Rail Services

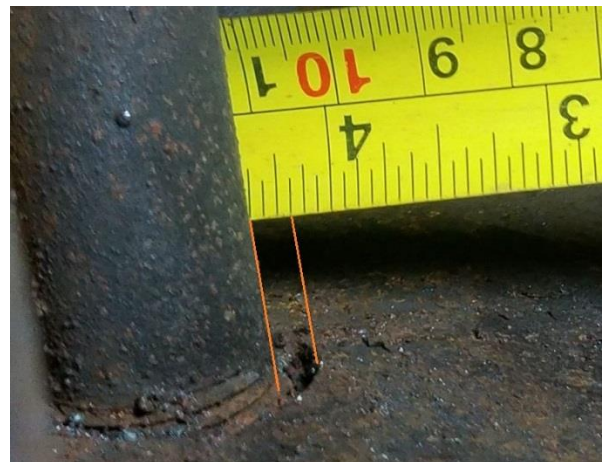
### 1) Rigid and Crown staybolts incorrectly installed.

The rigid bolts are installed utilizing a combination of fillet welding and threading. The FRA does not allow for the application of fillet welded bolts on non-chinese locomotives without prior written approval as it is not an accepted railroad practice nor (until summer of 2017) is it allowed by the ASME.

Though the ASME does now allow fillet welded installation, they must be applied under specific criteria as laid forth in PL-30. Specifically, parts PL-30.4, PL-30.4.2, and PL-30.4.4. This in turn violates CFR49 Part 230.29 (b) (1).

PL-30.4.2: A number of bolts do not have sufficient projection through fire side of the sheet to allow for 1/4" of weld without consuming the end of the bolt as prohibited by PW-19.2.

PL-30.4.4: All rigid and crown staybolts which can be observed from within the boiler have 1/8"+ clearance between the bolt and the sheet. Double allowable.

Due to the incorrect method of installation, all crown staybolts, and rigid staybolts must be removed and replaced. In order to properly install new staybolts, the firebox sheets must also be replaced due to the oversized, and damaged holes.

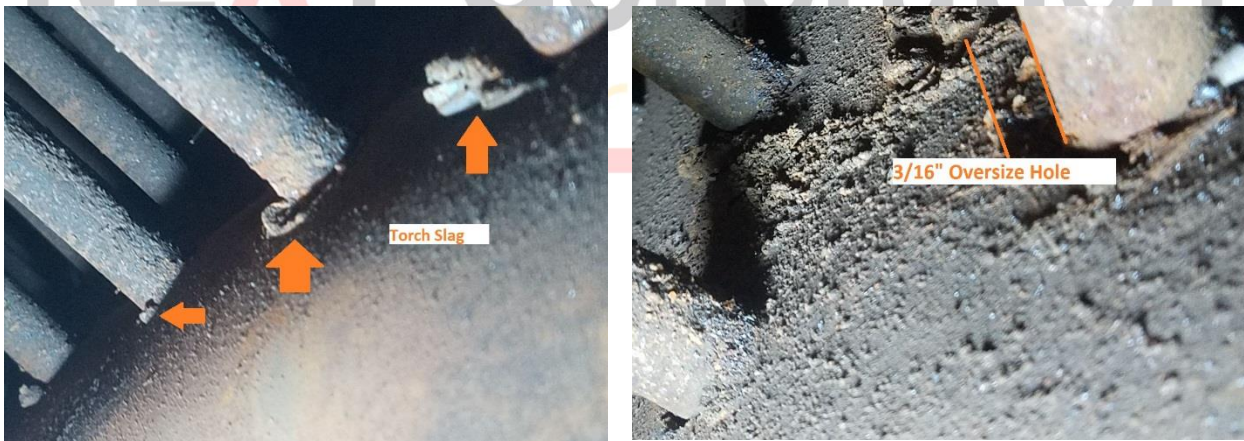
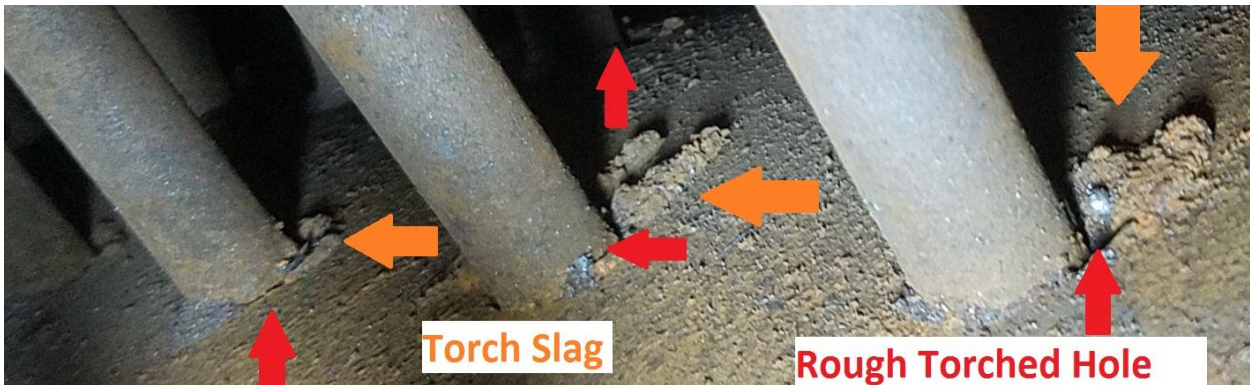
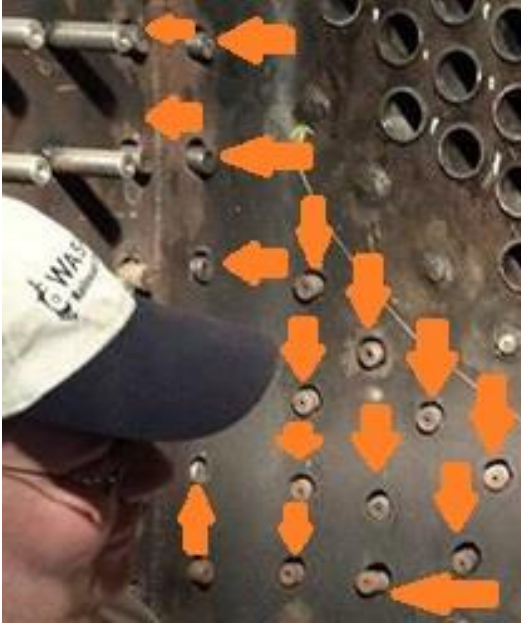
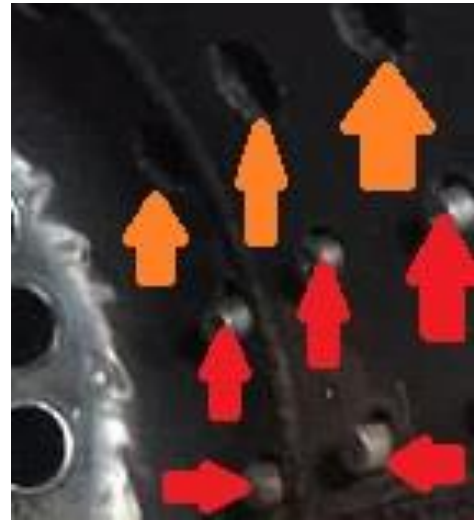
2) Flexible bolts installed via filet through torch cut holes which are between 1/8" to 5/8" oversized. This violates PL-30.4.4, and also PW-29.3.

PW-29.3: The surfaces left behind (throughout the firebox) by the torch cutting are not free of torch scale or slag (foreign material), and are also notched and consistently textured with deep striations. This in turn violates CFR49 Part 230.29 (b) (1). Hundreds such locations exist.

**The above depicts holes well in excess of 1/8" oversize on fluesheet**

**Orange denotes 2" diameter torch cut holes.**

**Red denotes holes in excess of 1/4" oversize in FR crown sheet**

Due to the incorrect method of installation, all flexible staybolts must be removed and replaced. In order to properly install new staybolts, the firebox sheets must also be replaced due to the oversized, and damaged holes.

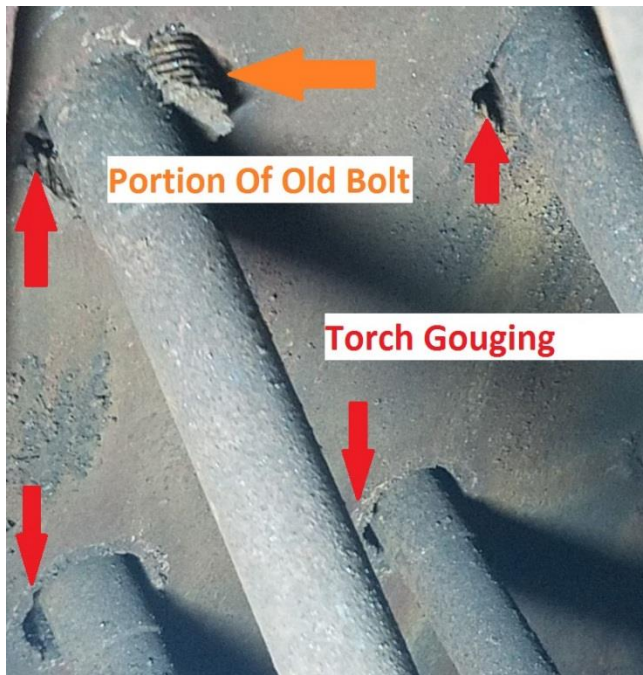
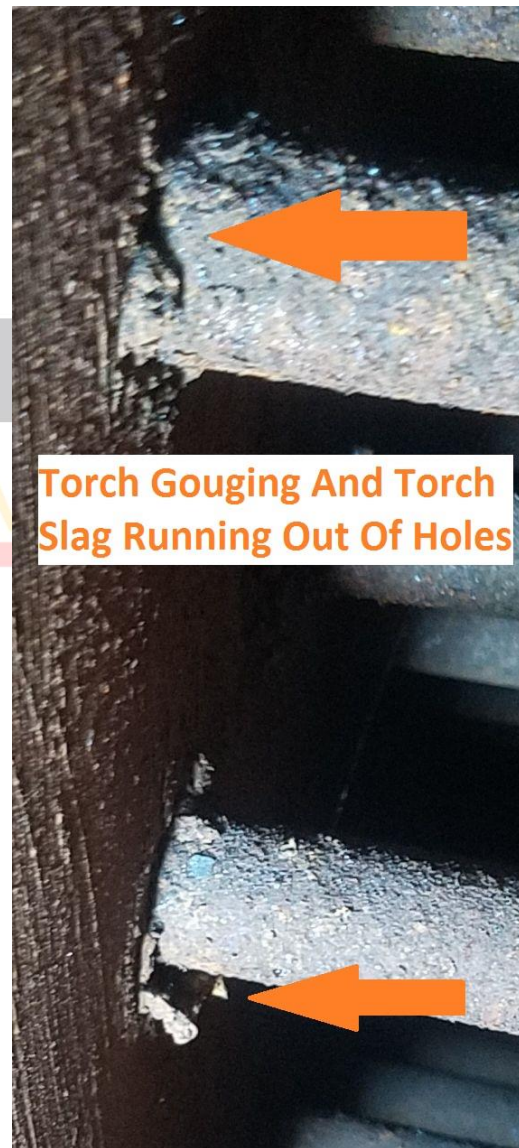
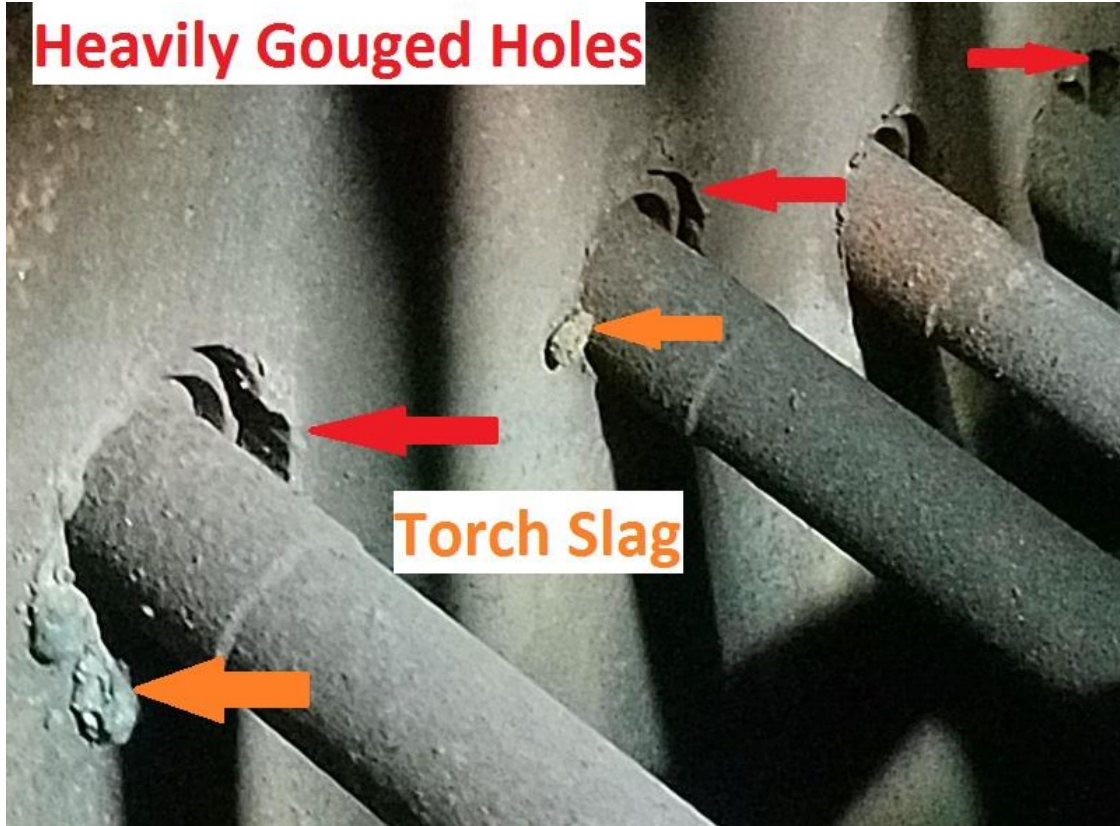
3) **All New Holes for flexible sleeves thermally enlarged. Torch scale, slag, gouges, and striations not removed prior to welding.**

In addition to the violations to code consistent with PW-29.3, the accompanying photos depict a portion of an original rigid bolt remaining alongside of (and partially consumed by) a rough cut hole. This in turn violates CFR49 Part 230.29 (b) (1). This boiler has approximately 300 flexible bolts.

Heavily Gouged Holes

Torch Slag

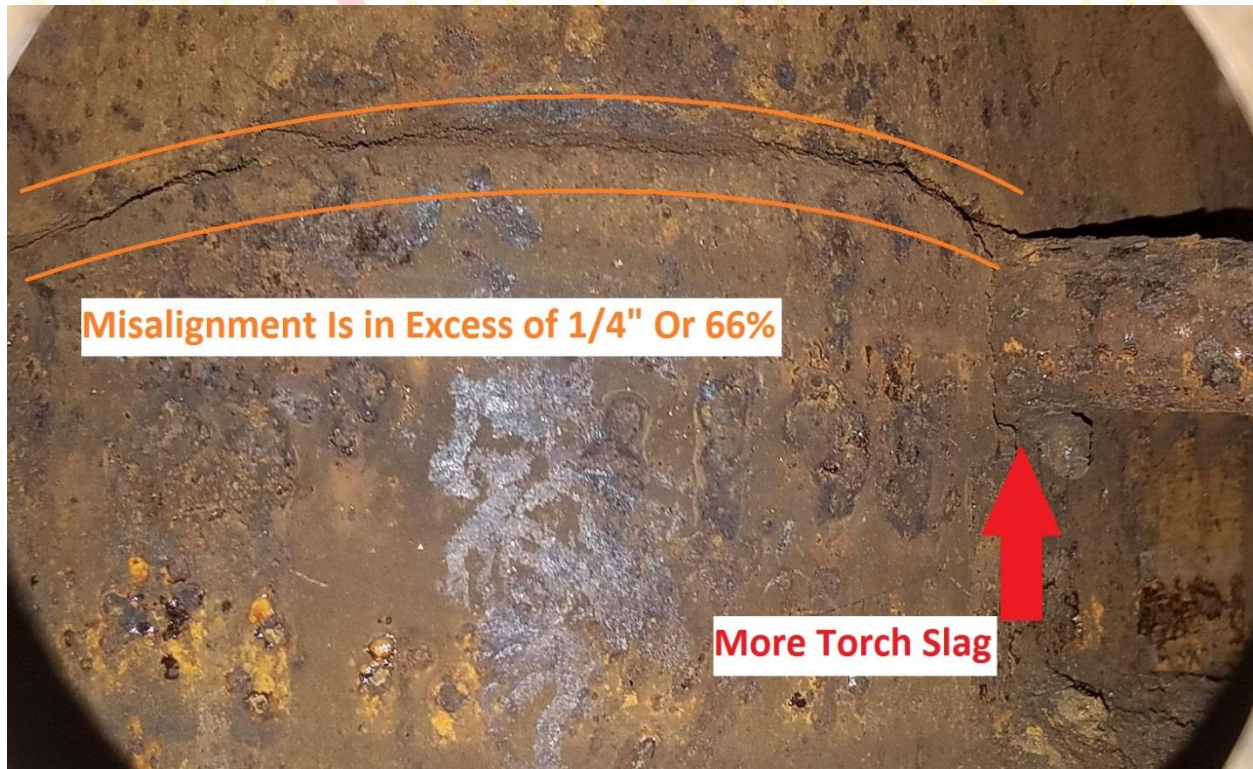
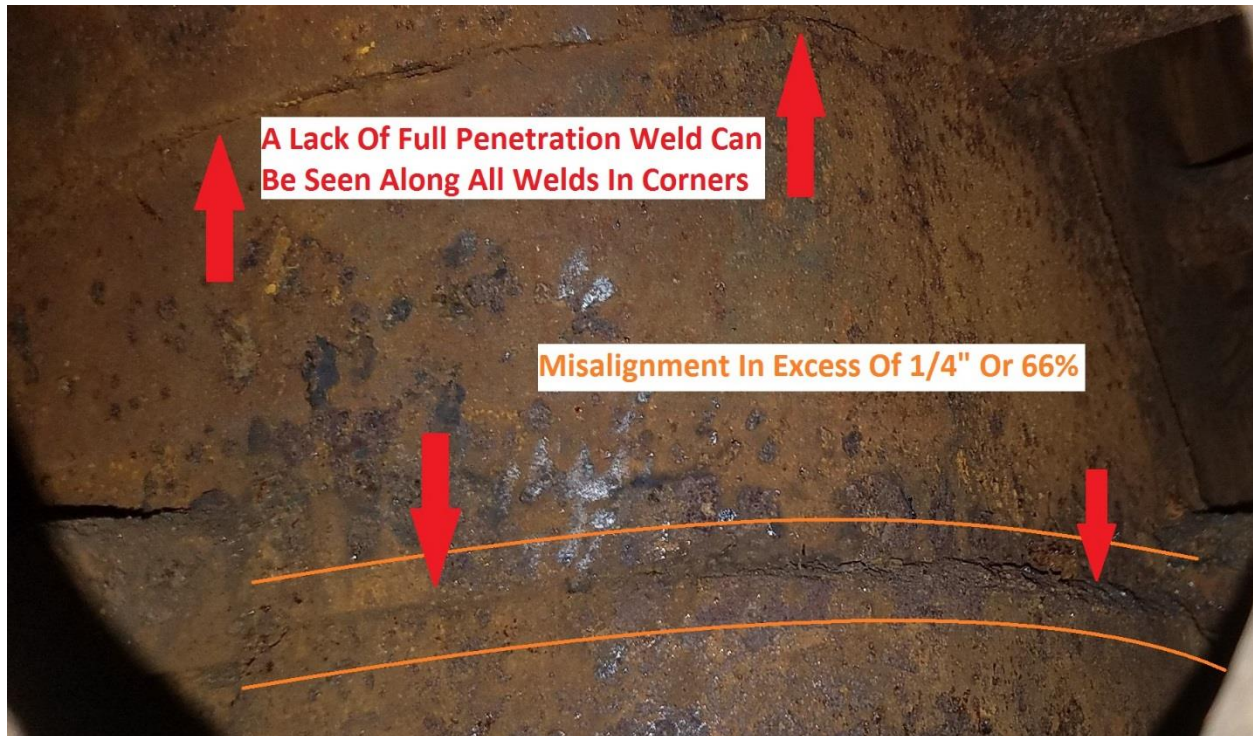
PW-9.1. states that all welds are to be full penetration. It can be seen from the above photos that there is no 1 in 3 blending of the above limit offset, and no sign of weld coming through to the waterside of the plate. This in turn violates CFR49 Part 230.29 (b) (1).

The defects associated with the corners require their replacement. This will be done in conjunction with items 1, 2, and 4.

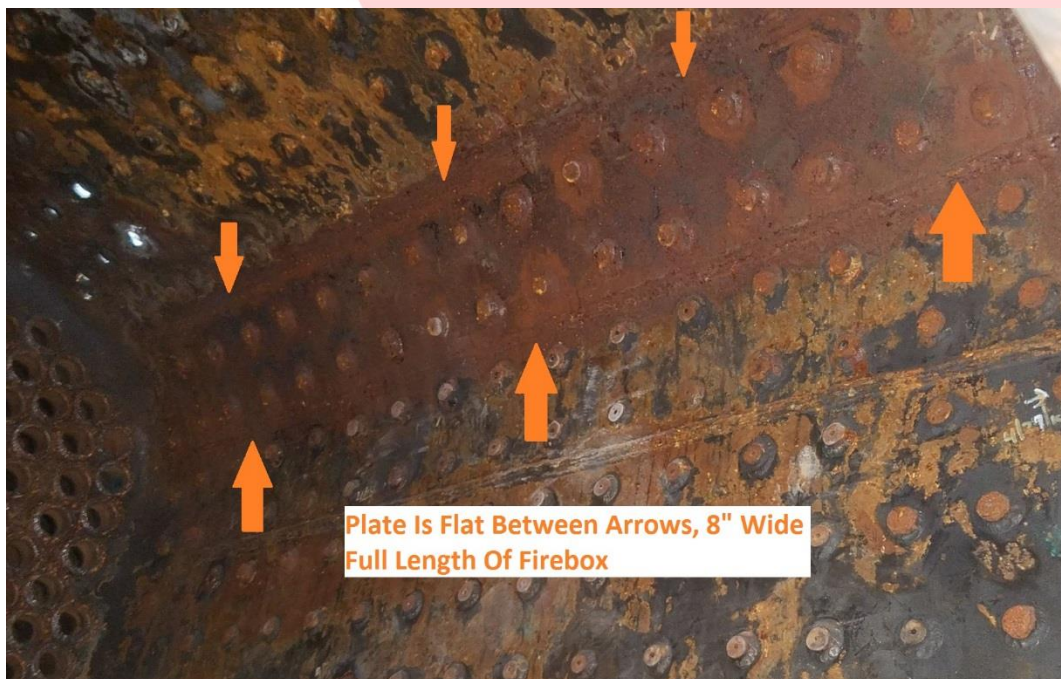
## 6) A Portion Of The New Firebox Was Replaced With Flat Plate In A Tight Radius

A sharply radiused portion of the new firebox was cut out and replaced with a piece of flat plate. This is contrary to O.E.M. design and violates railroad standard practice, and NBIC code. PW-9.3.1 states that the “middle lines” of the plate are to be aligned, these are not as one is radiused and the other straight. When replacing a portion of any boiler it is to be replaced “in kind” to the original. This in turn violates CFR49 Part 230.29 (b) (1).

This defect requires the replacement of the flat plate with a piece of material formed to properly match the centerline of the adjoining plate. This will be corrected in conjunction with items 1, 2, and 3.

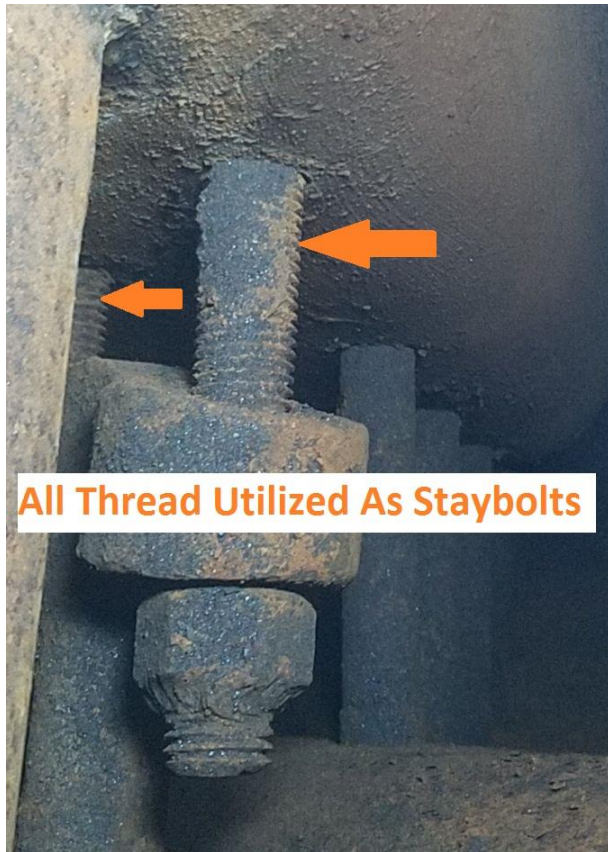
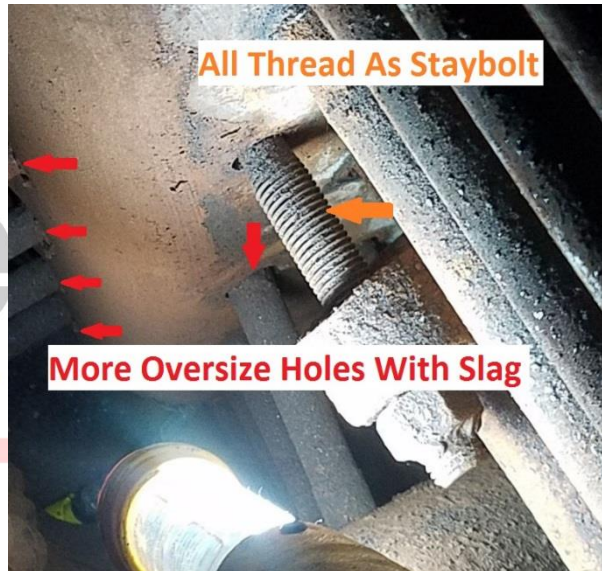
## 7) “All Thread” Utilized As Staybolt Material

All of the staybolts between the belly braces and rear tubesheet consist of an “all thread” material. ASME and NBIC specify that acceptable staybolt materials shall comply with SA36 or SA675. Commercially made “all thread” does not comply with either of these material specifications. This style of belly brace is designed to utilize a flexible staybolt, there is a socket beneath the nuts which do not generally contact the brace. This in turn violates CFR49 Part 230.29 (b) (1).

These pieces of non-code, improper design material will be replaced with flexible staybolts. This will be accomplished in conjunction with items 1, 2, 3, and 4.

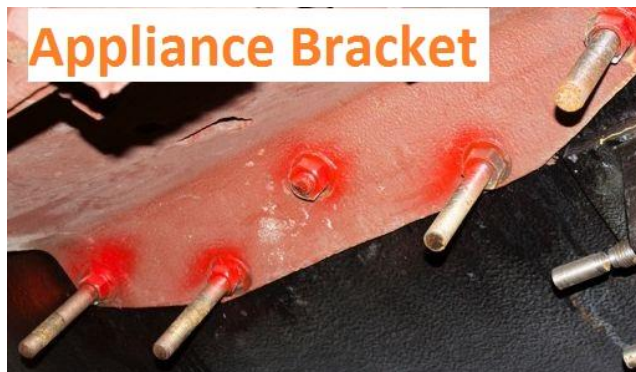
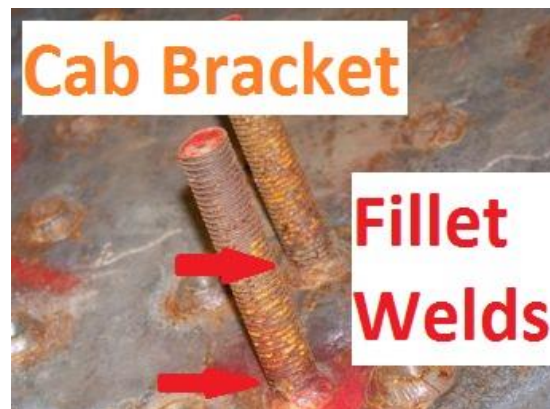
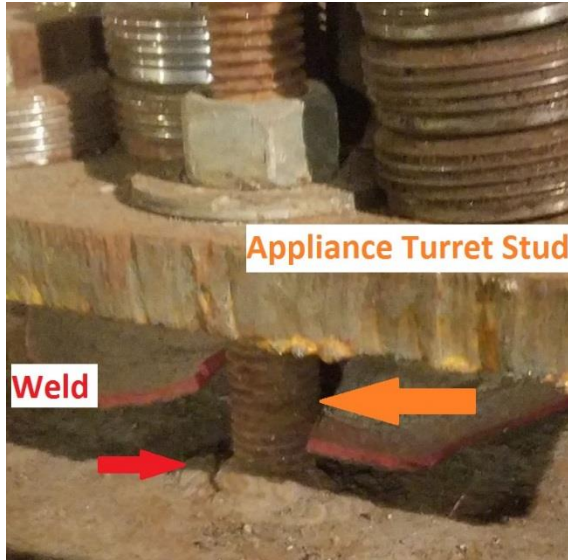
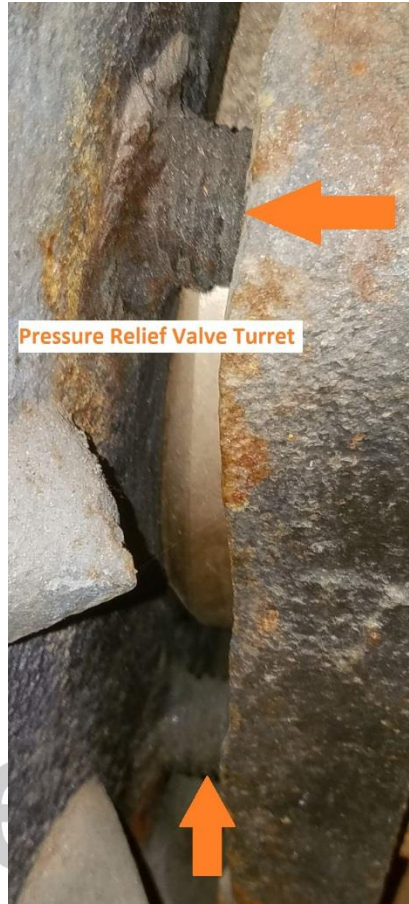
## 8) “All Thread” Utilized As Studs At 62 Locations Around The Barrel And Firebox, Installed Into Torch Cut Holes

A commercial grade “all thread” material was utilized. There are no commercially available “all thread” materials which are approved for welding into steam boilers. The pieces of “all thread” were installed into torch cut holes. Code does not allow for the welding of threads into a pressure vessel. This in turn violates CFR49 Part 230.29 (b) (1).

There are multiple locations around the pressure vessel at which these incorrectly applied studs are pressure retaining. These are especially concerning because when they do fail there would be a sudden and uncontrolled release of steam. Due to the proximity of the effected attachments to crew or the public, it is almost guaranteed scalding injuries would occur.

All “all thread” studs must be replaced with studs of a proper material, and utilizing a proper installation practice. There are 3 repair options and they would need to be discussed with the FRA to determine which they are most comfortable with, though all 3 do meet code requirements. The repair options are: 1) Full penetration welded installation of code material, 2) Weld build up and re-tapping of all effected holes, 3) Replace the boiler barrel with one of new, all welded construction.

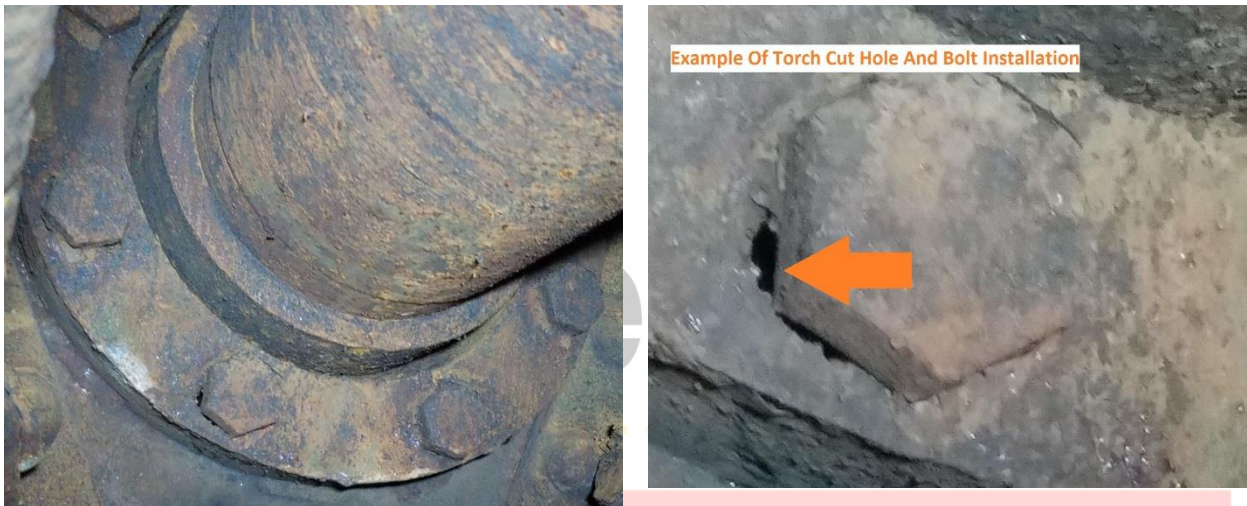
### 9) Bolts Welded Into The Vessel As Studs For Attachment Of Delivery Tee, Bolts Installed Through Torch Cut Holes

The issues with the bolts are no different than those of the studs, the use of bolts is not a compliant practice. The bolts are installed through torch cut holes, leaving behind gouging and striations. As discussed above, PW-29.3 prohibits these physical conditions. The integrity of the reinforcing ring has been compromised. This in turn violates CFR49 Part 230.29 (b) (1).

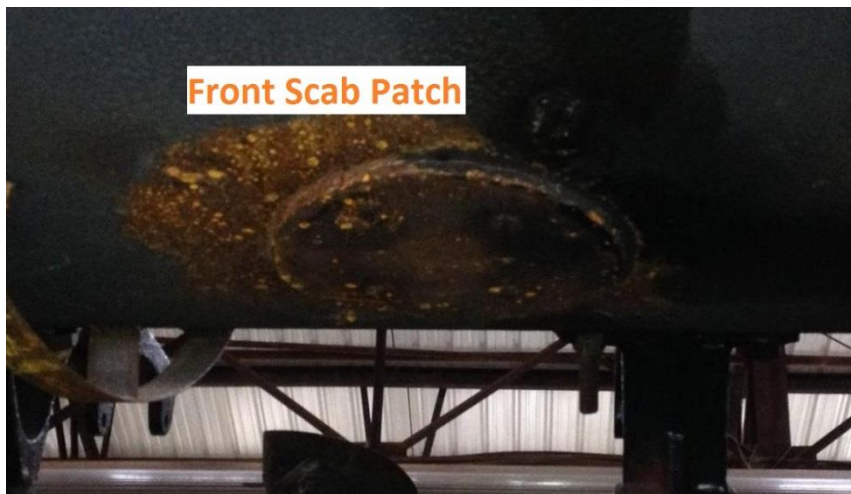
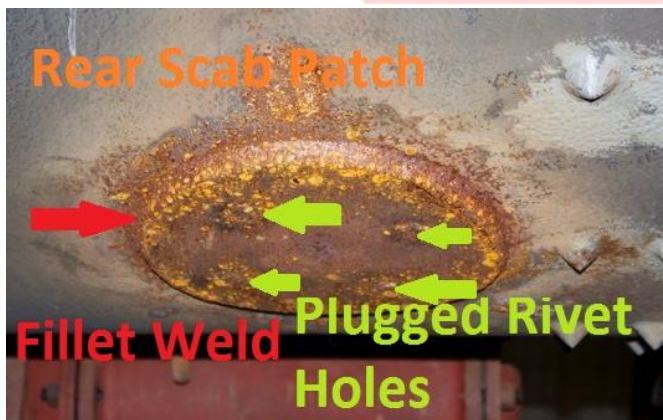
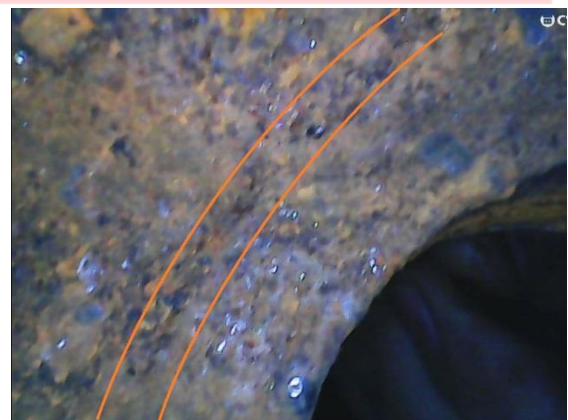
### 10) Non-compliant Application Of Nozzles And Scab Patches To Belly Of Barrel

Reinforcing liners for the application of washout plug sleeves were applied via file weld after the tubes were installed. Holes were then cut for application of the sleeves (referred to as nozzles), though the nozzles appear to have only been welded to the liner. This is determined via exterior inspection revealing inadequate beveling around the nozzle for full penetration 1 ¼" of material, and a borescope inspection which shows a seam on the waterside of the nozzle.

These conditions are in contradiction to PW-16.1

Orange lines show seam between nozzle and boiler barrel. This seam is large enough to show up through the thick layer of debris in the belly.

The reinforcing ring requires replacement to correct for the torch cut holes. Depending upon the appearance of the fluesheet once the non-code material is removed, a patch may be required.

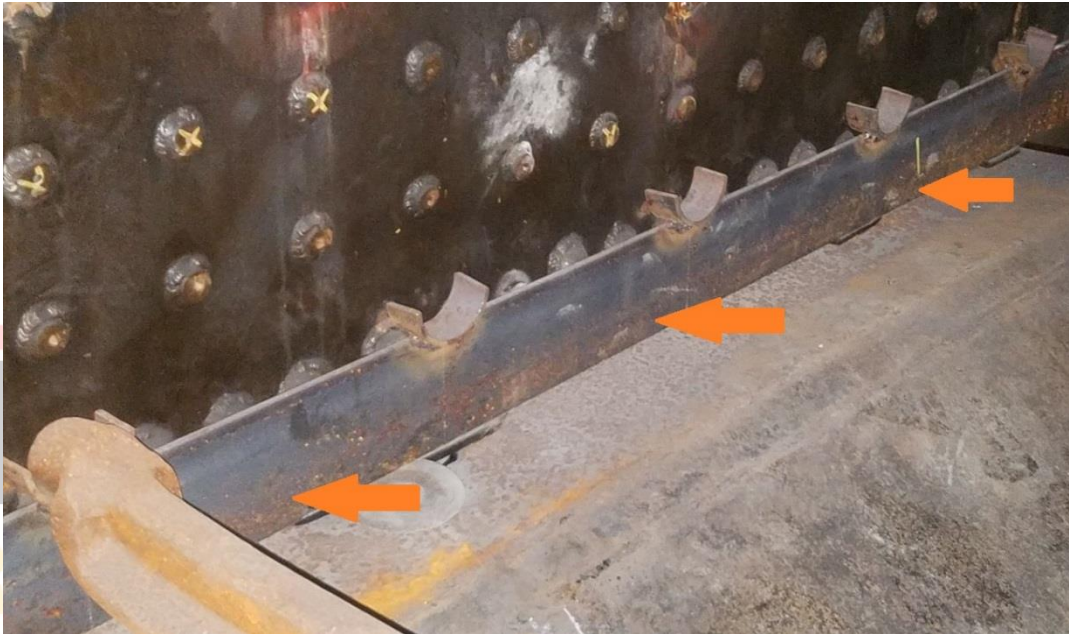
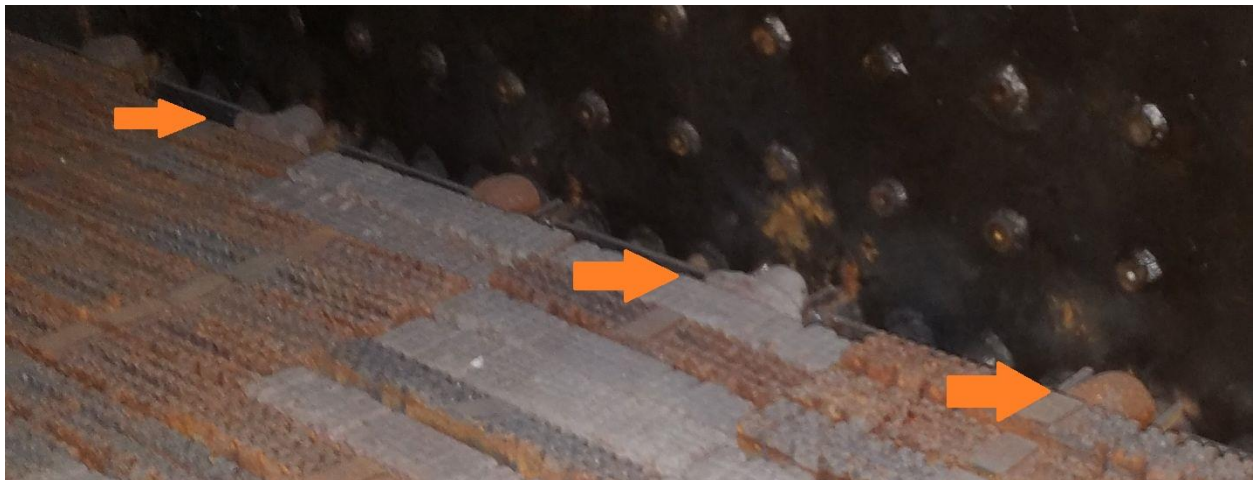
## 12) Side Grate Bearers

The side grate bearers consist of thin steel fabrications. Standard practice dictates these to be heavy/solid iron castings of an appropriate alloy. This is required as steel will burn, warp, and quickly fail.

The side grate bearers require replacement with an appropriate design, properly alloyed, iron casting.

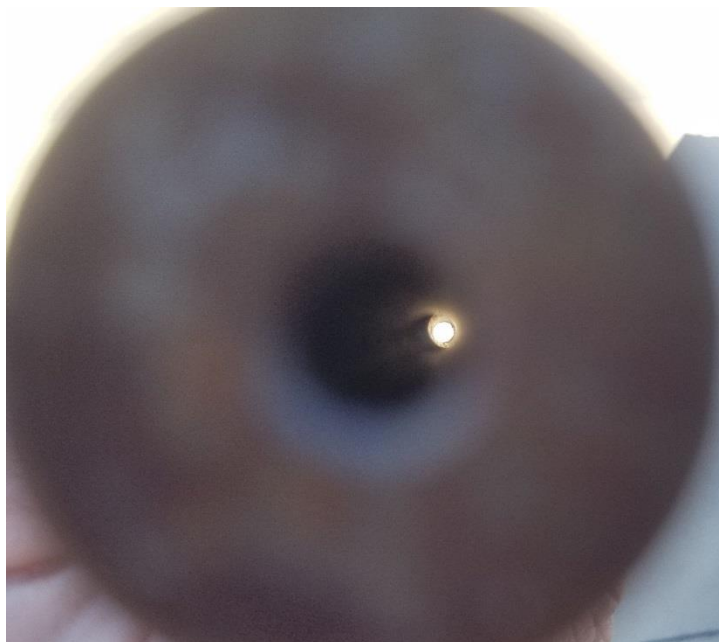
13) **Rigid Bolt Telltale Holes Drilled From Both Sides**

The telltale holes are drilled from both ends of the bolt, many do not lineup from one end to the other. Numerous bolts exhibit holes which are misaligned by  $\frac{1}{2}$  of the hole diameter. This results in an inability to clear telltales in accordance with CFR 49 230.38 (c) as is evidenced by numerous broken drill bits left behind in the installed bolts. Bolts must be cleared so that when a bolt breaks, steam/water can be observed escaping.

All bolts with misaligned holes require replacement due to the inability to be able to clear the telltale with a drill bit. This condition has already revealed itself as a problem as evidenced by some 12+ drill bits having broken off due to the misaligned holes.

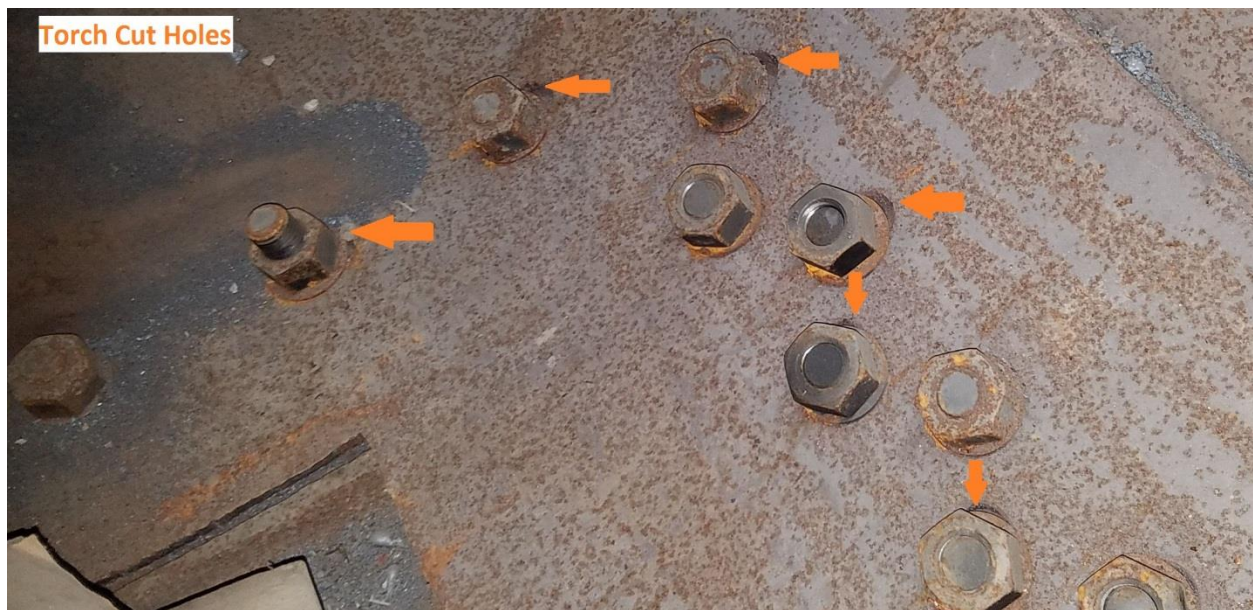
#### 14) **Incorrectly installed Saddle Bolts**

The saddle bolts (bolts connecting the smokebox to the cylinder casting) are of incorrect design and installed incorrectly. Railroad standard practice calls for the saddle bolts to be of a taper fitted type bolt, these are commercially available, straight shank, black oxide bolts. The bolts were installed through dramatically oversized torch cut holes, versus the tight and machined fit standard practice calls for. Additionally, standard practice dictates that bolts be installed from the inside with nuts on the exterior, these bolts are installed upside down.

Due to the oversized holes, the bottom of the smokebox will require replacement to accommodate the installation of custom machined, taper fitted bolts. This installation practice for ALCO, Baldwin, and Lima, as well as every mainline railroad within the United States.

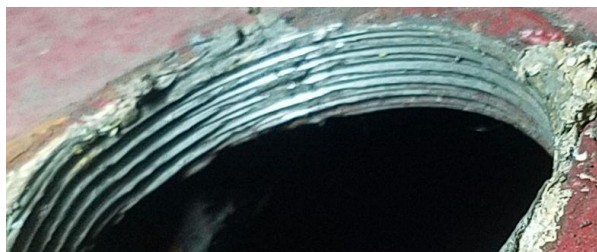
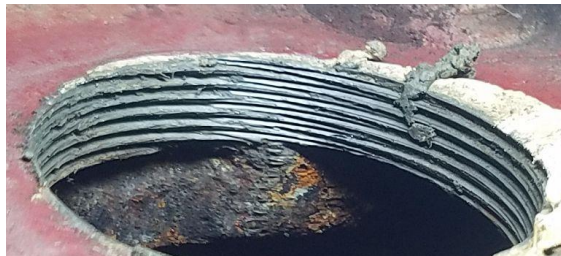
#### 15) **Washout Plugs Of Incorrect Material, Holes Cross-Threaded**

All washout plugs are machined from a steel material. It is a well-accepted fact that steel plugs will seize in their threaded hole when utilized in locomotive boiler service, standard practice dictates the use of SB-61 bronze. Several holes are severely cross threaded.

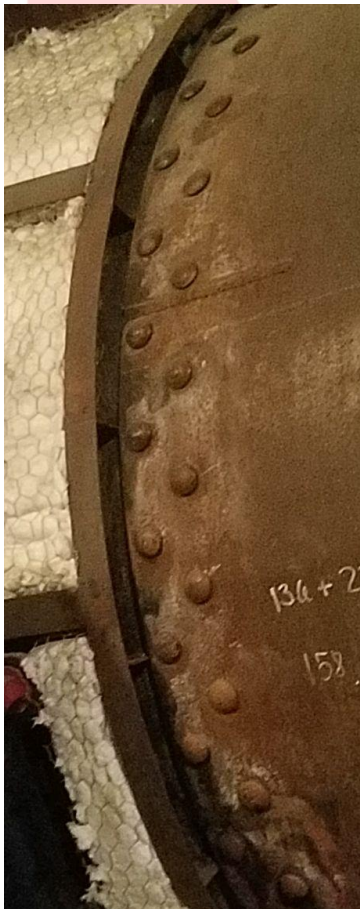
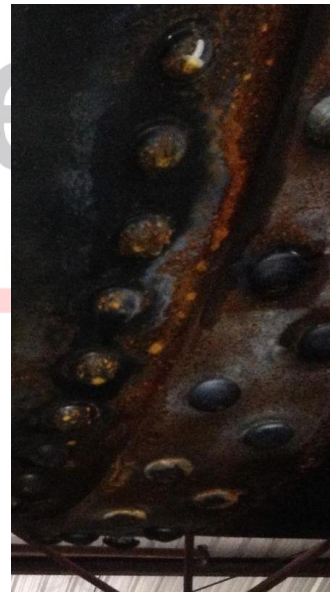
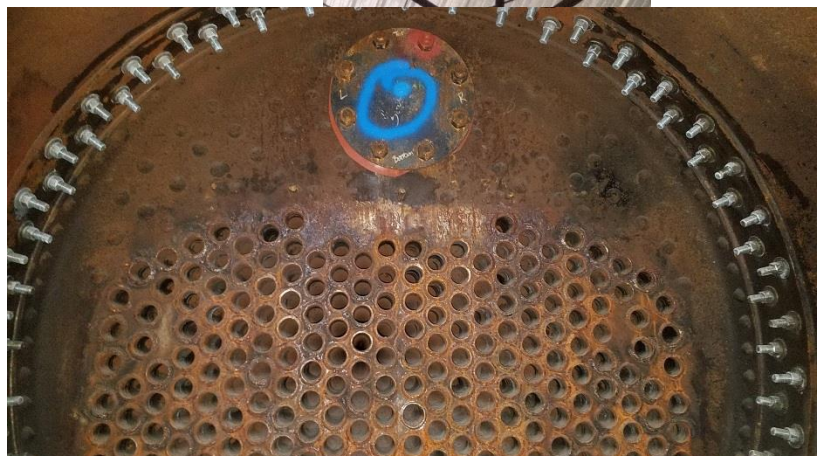
17) **Attachment Of Smokebox To Boiler Barrel**

The boiler and smokebox have been joined by generic/hardware store carriage bolts. Standard railroad practice calls for attachment via rivets. The exterior of the bolts were heated and driven with an air hammer, presumably to make them look more like rivets. This Joint will allow movement between the boiler and the smokebox which will ultimately lead to cracking in the frame.

All carriage bolts need to be removed and replaced with hot driven rivets in accordance with standard practice.

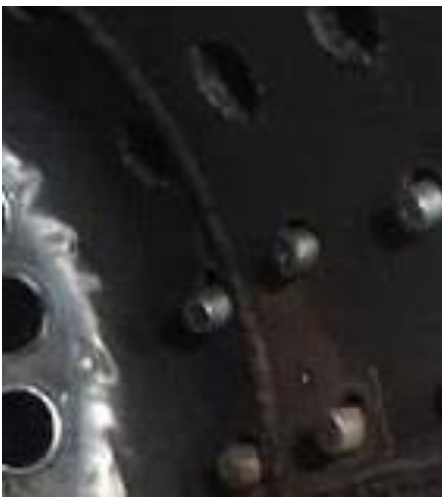
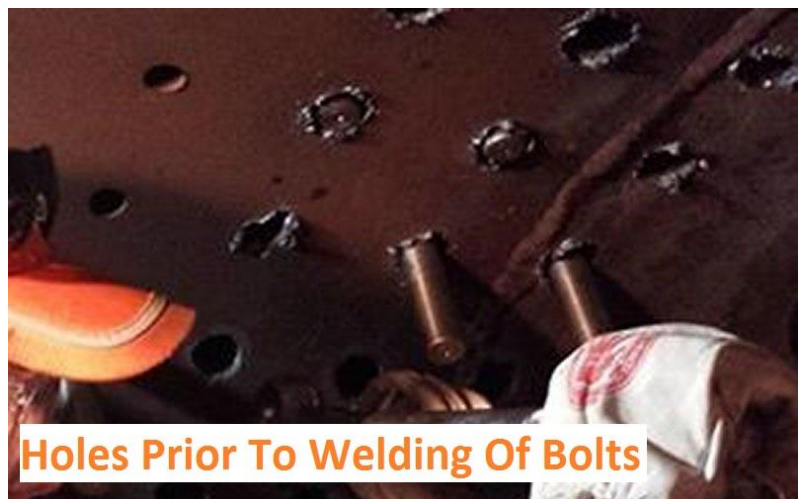
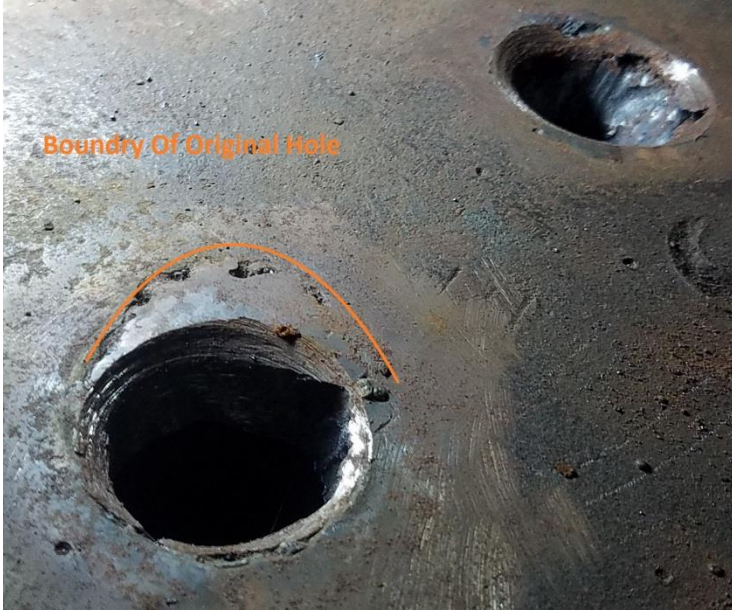
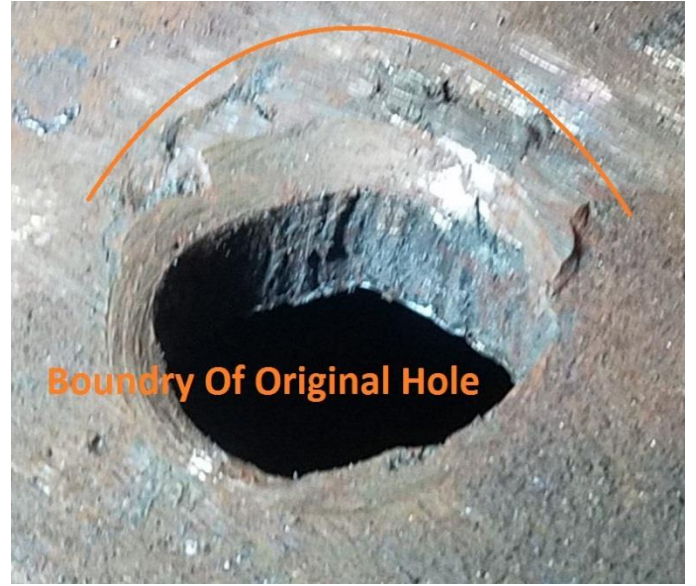
## 18) No Flexible Bolts In Backhead

The firebox of the 14's boiler has received \*most\* of an AAR flexible staybolt pattern. While upgrading a locomotive boiler to having a full AAR flexible bolt pattern is a railroad standard practice, and highly advisable, it must be done in full. In this case, the backhead received no flexible bolts. The result of this incomplete installation will result a high occurrence of broken bolts around the backhead due to allowance for additional movement along the ends of the sidesheets.

The first three rows of bolts had dramatically oversized holes (double bolt diameter, several of which are still visible. Those still visible are approximately 7/16" oversized. Approximately 18 bolts have been removed to allow for the weld build up of the holes. This was done so poorly that the original enlarged diameter is still visible at multiple locations as well as pockets of slag within the welds.

While it is unclear as to why, the water side surface of the sheet has been built up with weld. The thickness of the .375" sheet has increased to over .625". I conclude that this was done for the purpose of hiding sheet misalignment. The welding rod utilized for this welding is not appropriate for use on pressure vessels.

These torch-cut, oversized, and then incorrectly repaired holes require replacement of the effected sheet. This will be accomplished in conjunction with items 1, and 2.

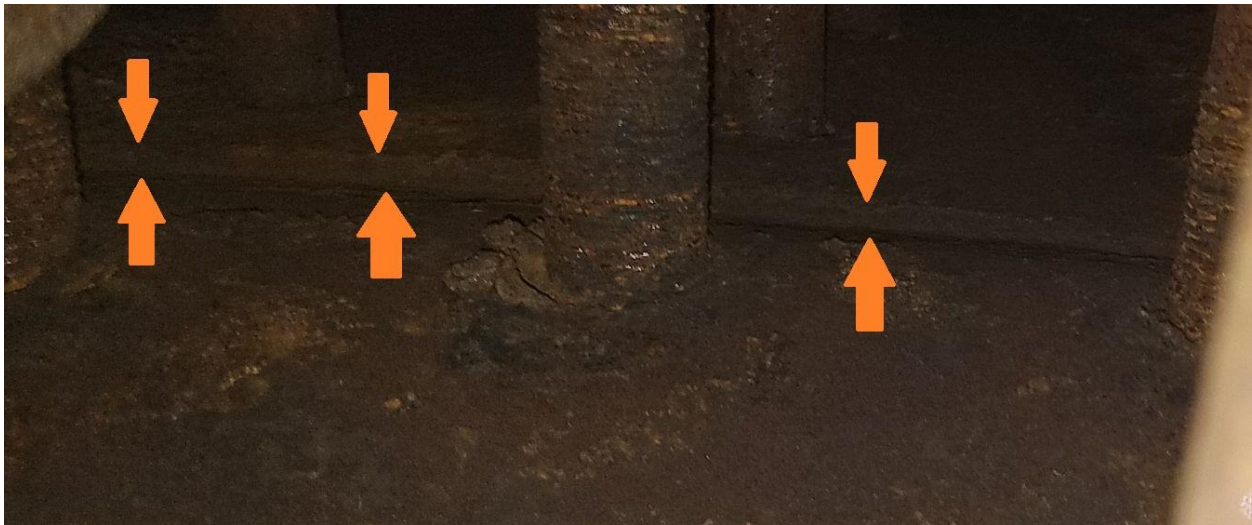
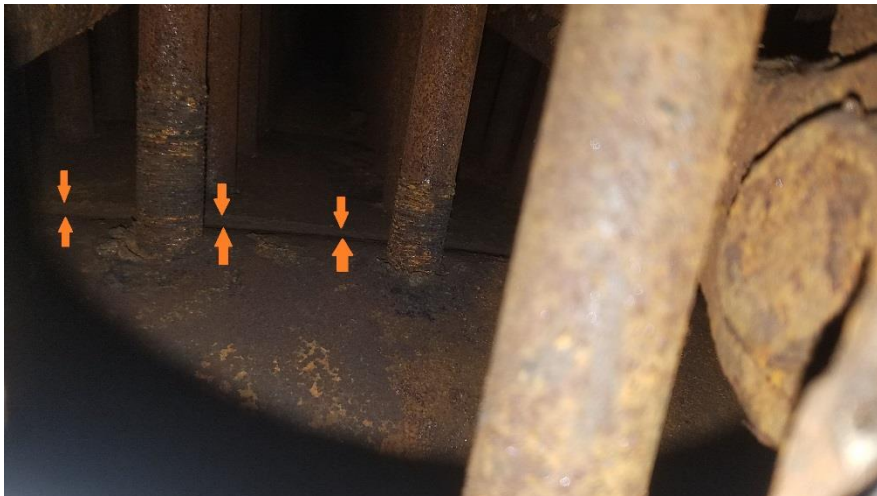
## 20) Crown To Doorsheet Fit-up

The welded joint between the crown sheet and doorsheet was found to be far in excess of ASME/NBIC parameters. These standards were discussed above regarding the corners. In addition to the sheet misalignment, the accompanying photo depicts torch cut holes, and threads present in the welds joining the bolts to the crown sheet.

What was unable to be adequately captured in photos is the amount of misalignment. At the center of the crown sheet it is almost full sheet thickness. In order to achieve this fit up, only the leading edge of the doorsheet knuckle was bent upward. When the new sheet was made the knuckle was bent about 10 degrees beyond 90 to allow for fit up. Instead of just the leading edge, the

transition in alignments should have flowed back into the radius.

This defect requires replacement of either the doorsheet or the crownsheet. This will be accomplished in conjunction with items 1, 2, 4, 5, and 6.
