# **K&T #14**

## **Inspection Overview, Observed Defects & Corrective Actions**

Jason Sobczynski  
Next Generation Rail Services

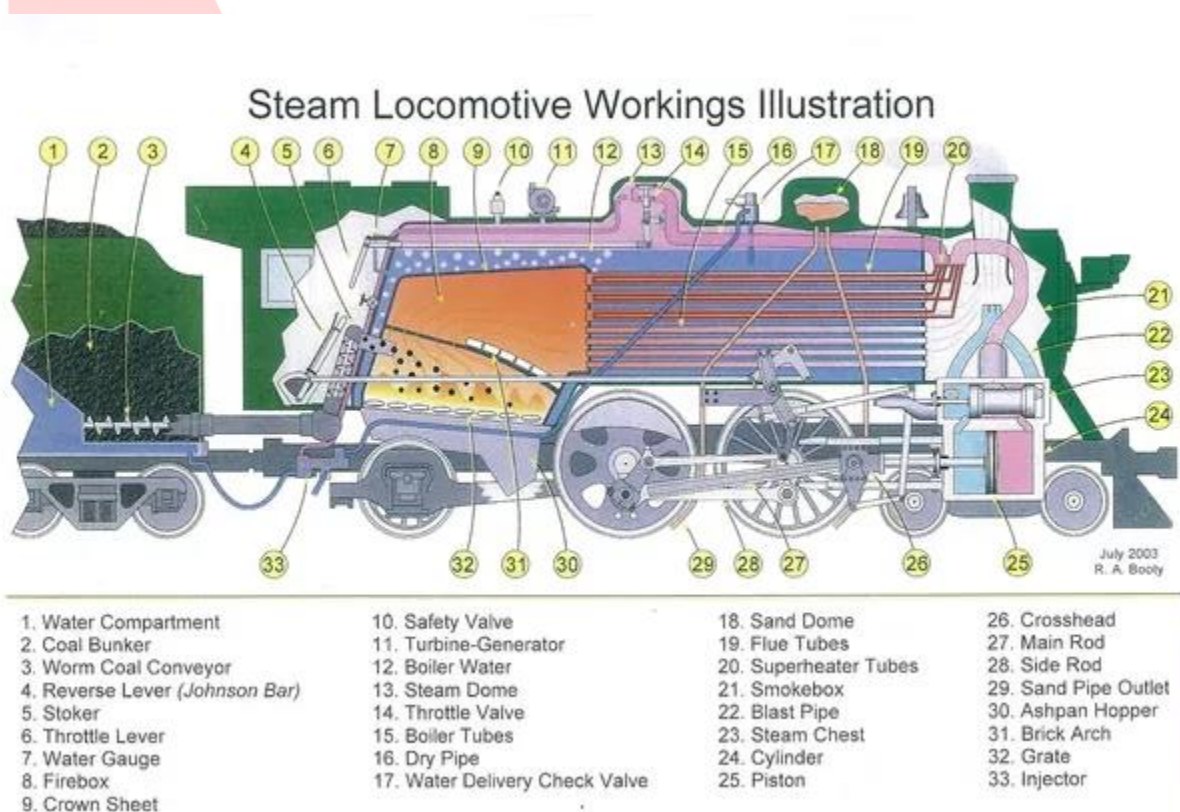
This image provides a perspective as to the manner in which the boiler is integrated into the locomotive.

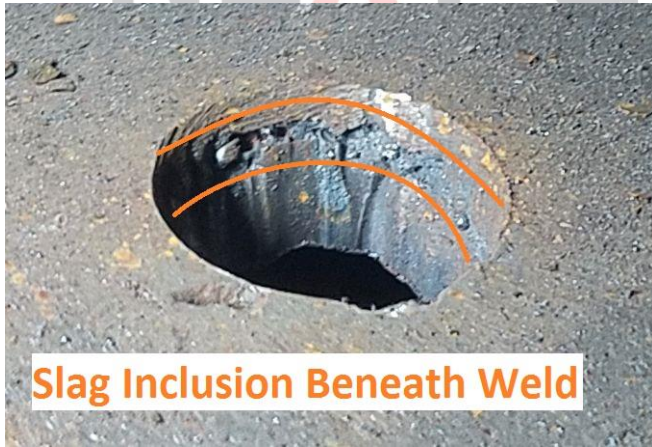
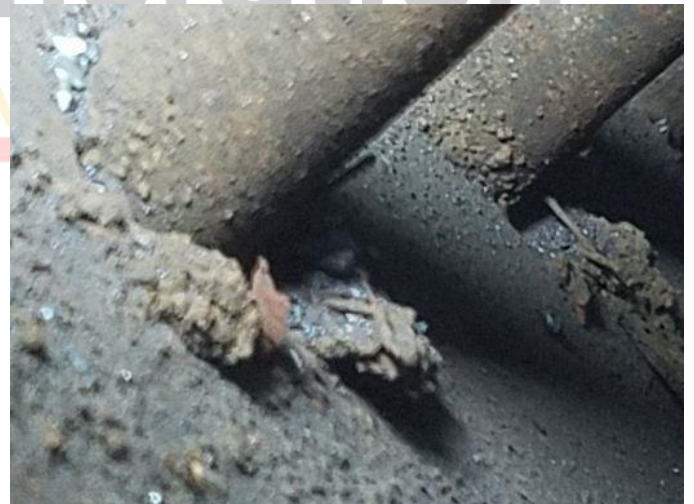
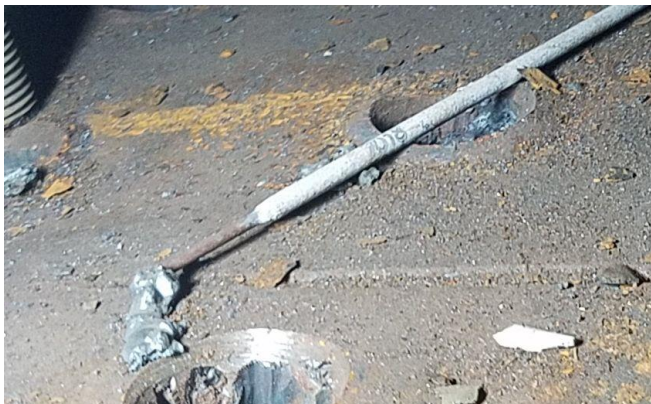
## 20) Crown To Doorsheet Fit-up

The welded joint between the crown sheet and doorsheet was found to be far in excess of ASME/NBIC parameters. These standards were discussed above regarding the corners. In addition to the sheet misalignment, the accompanying photo depicts torch cut holes, and threads present in the welds joining the bolts to the crown sheet.
